## Decades-Long Impact of Topsoil Removal

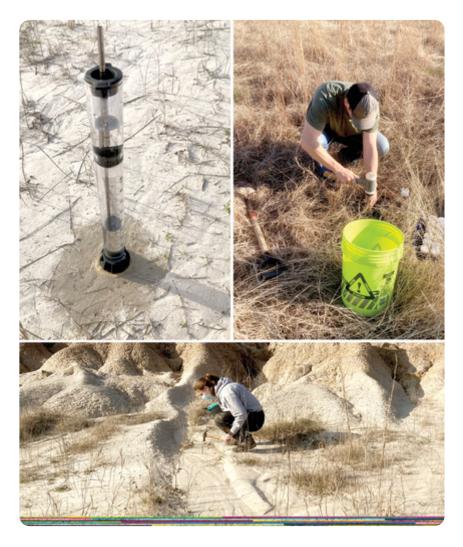
Clockwise from top: A mini disk infiltrometer measures infiltration of water into soil in the disturbed area, Texas A&M University grad- uate student Parker Murphree collects soil

samples to determine soil texture, and Texas A&M University graduate student Steph- anie DeVillenueve measures soil erosion in an area where a large amount of soil was previously removed. Photos by Briana Wyatt.
